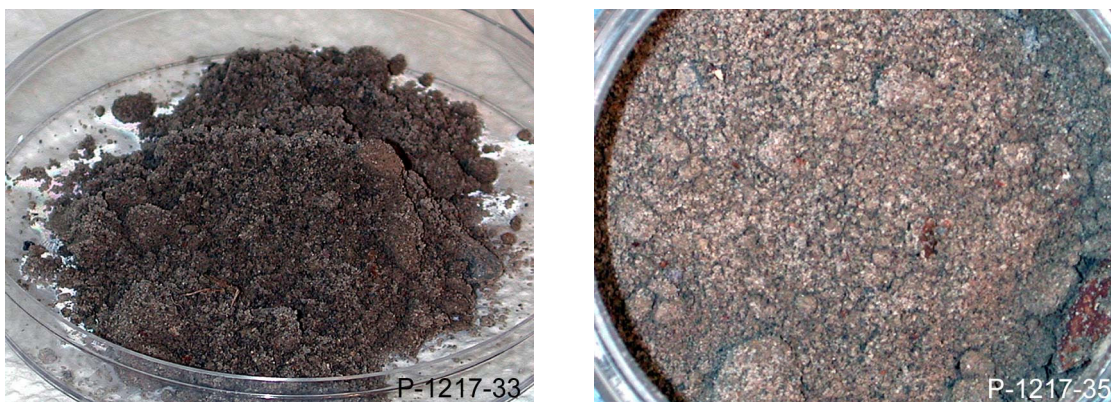
Figure C-16. A photographic image of sample P9GT08016G in a dish (left) in a jar (right).

Sample P9GT08016G was collected on February 13, 2004 at 17:40 hr at a reach of 8.81 ft, an angle of 12 degrees, and a depth of 12.47 ft. The scoop was #1247. The justification for this particular sample was recorded as soil that was located under a drum next to the probe cluster. The drum was known to contain graphite pieces. The material in the transfer cart was described as mostly light-colored soil with areas of high moisture. The condition of the drum liner that contained the graphite pieces was recorded as mostly dirty with darker moisture content. The interstitial soil characteristics were described as granular. No free liquid was noted. The sample characteristics were detailed as moist granular soil located beneath a steel drum containing graphite pieces.

The sample was collected from beneath a steel drum containing graphite pieces.

The sample appeared to be clean soil with no major foreign debris apparent except a few minor pieces of rusted drum. Subsamples free of any foreign debris were easily acquired. Minor pieces of corroded drum were easily segregated. Soil was still moist causing a darker appearance. Vermiculite, plastic, paper, or sludge were not observed.

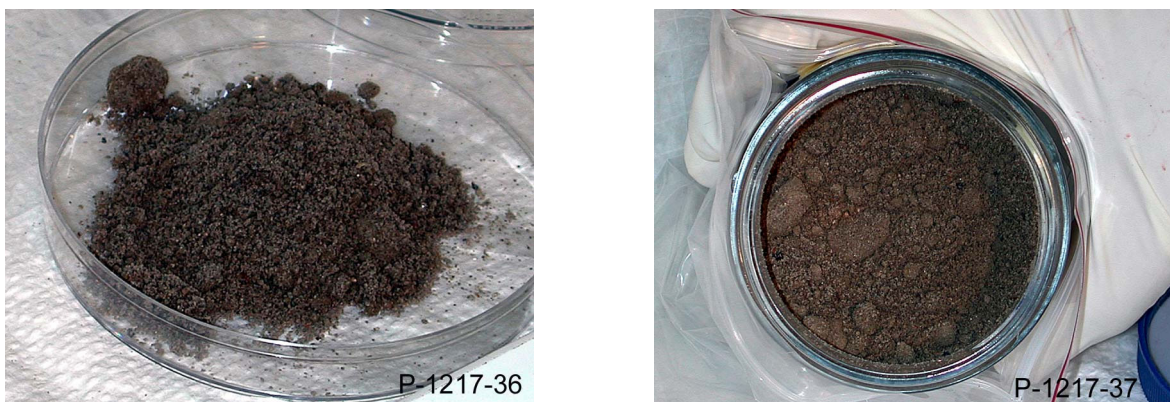
Figure C-17. A photographic image of sample P9GT09016G in a dish (left) in a jar (right).

Sample P9GT09016G was collected from scoop #1246 on February 13, 2004 at 17:40 hr at a reach of 8.81 ft, an angle of 12 degrees, and a depth of 12.47 ft. The justification for this particular sample was recorded as soil that was located under a steel drum that contained graphite pieces and located next to the probe cluster. The soil is described as light-colored soil with areas of high moisture. The interstitial soil characteristics were described as granular and are the same as noted for the previous sample (P9GT08016G). No free liquid was noted. The sample characteristics were detailed as moist soil.

The same description applies as provided for sample P9GT08016G.

The sample appeared to be a clean soil sample. No visual signs of rust or sludge were noted. The sample was described as visually clean soil.

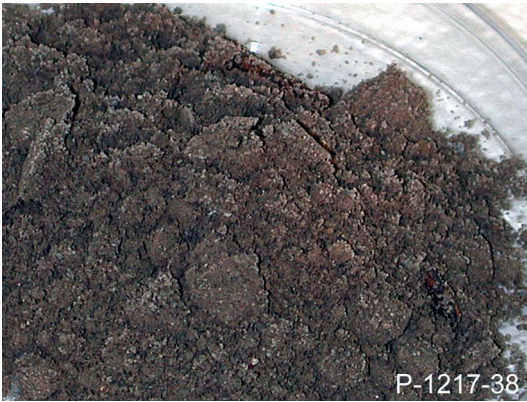
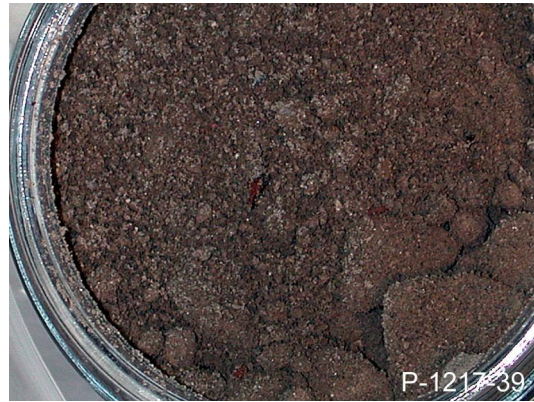
Figure C-18. A photographic image of sample P9GT10016G in a dish (left) in a jar (right).

Sample P9GT10016G was collected from scoop #1281 on February 14, 2004 at 22:42 hr at a reach of 9.42 ft, an angle of 11 degrees, and a depth of 14.79 ft. This scoop of material was acquired after four clean scoops of soil were removed from just to the right of the P9-20 probe cluster. The material was described as very moist granular soil located just to the left of the drum containing wood pieces and just to the right of the probe cluster. The drum containing wood blocks located at an angle of 10 degrees and a depth of 13 ft, when removed, uncovered a void that contained standing water. Soil was used to absorb the water. Scoop #1281 was acquired from 11 degrees and 1.79 feet below the void. It was suspected that some of the free-standing water was absorbed by the nearby soil. No sludge was present in the sample. The interstitial soil characteristics were described as fine to medium grade. According to the hue guide chart (Geological Society of America 1991), the sample was recorded as 5YR 6/4-10YR 5/4 (light brown to light yellow brown). No free liquid was present, although the sample was moist to very moist. It was unknown whether the moisture was due to standing water absorbed earlier, or was the original state of the material in that location of the pit. No organic sheen was observable. The sample material consisted of fine to medium granules of soil.

Exposed dumped drums and drum liners were present nearby. A rusted drum and a stained bag were present. The integrity of nearby drums was described as poor as a result of being thoroughly corroded and rusted and exposed to significant moisture. The drum liners observed were listed as being in conditions ranging from fair to poor. Moisture was present in the sampling region. The soil did not appear to be stained, only moist. Cardboard pieces and rusted metal pieces were listed as nearby debris. Clear plastic bags with opaque, stained, yellow tape were also present.

The sample appeared to be moist soil with no obvious or visible foreign debris. No rust or corroded drum pieces were present.

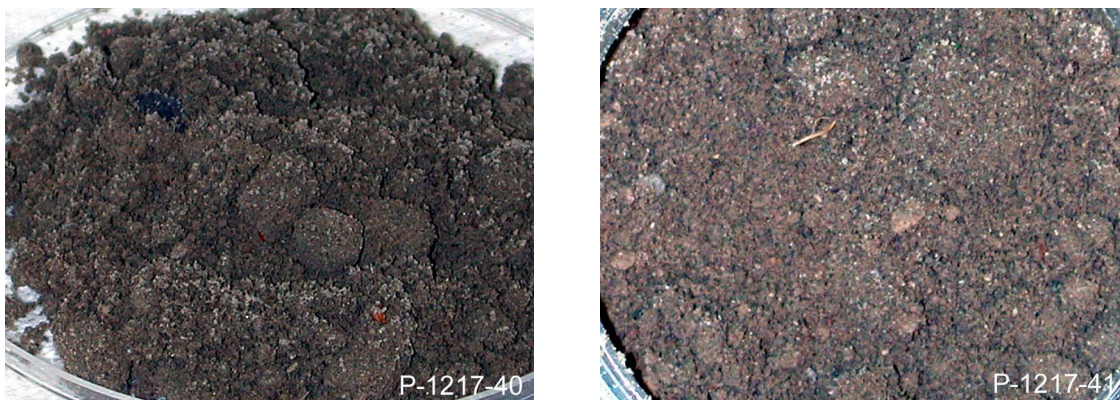
Figure C-19. A photographic image of sample P9GT11016G in a dish (left) in a jar (right).

Sample P9GT11016G was collected from scoop #1281 on February 14, 2004 at 22:42 hr at a reach of 9.42 ft, an angle of 11 degrees, and a depth of 14.79 ft. The field characterization identified the sample as interstitial soil. This scoop of material was acquired after four clean scoops of soil were removed from just to the right of the P9-20 probe cluster. The sample material consisted of fine to medium granules of soil. The material was described as very moist granular soil located just to the left of the drum containing wood pieces and just to the right of the probe cluster. The drum containing wood blocks located at an angle of 10 degrees and a depth of 13 ft, when removed, uncovered a void that contained standing water. Soil was used to absorb the water. Scoop #1281 was acquired from 11 degrees and 1.79 feet below the void. It was suspected that some of the free-standing water was absorbed by the nearby soil. No sludge was present in the sample. The interstitial soil characteristics were described as fine to medium grade. According to the hue guide the sample was recorded as 5YR 6/4-10YR 5/4 (Geological Society of America 1991) (light brown to light yellow brown). No free liquid was present although the sample was moist to very moist. It was unknown whether the moisture was due to standing water absorbed earlier, or as the original state of the material in that location of the pit. No organic sheen was observable. In the laboratory, after visual inspection and photographs, subsamples were obtained for analysis.

Exposed dumped drums and drum liners were present nearby. A rusted drum and a stained bag were present. The integrity of nearby drums was described as poor as a result of being thoroughly corroded and rusted and exposed to significant moisture. The drum liners observed were listed as being in conditions ranging from fair to poor. Moisture was present in the sampling region. The soil did not appear to be stained, only moist. Cardboard pieces and rusted metal pieces were listed as nearby debris. Clear plastic bags with opaque, stained, yellow tape were also present.

The field characterization identified the sample as interstitial soil. During photography, the sample was described as clean soil. Very minor amounts of foreign materials were easily segregated (e.g., small piece of drum rust and a small wood piece). Rust was not abundant; a piece of white chunky material was evident and segregated. Small pieces (<5 mm) of basalt were noted and segregated when the sample was transferred into the petri dish for photography.

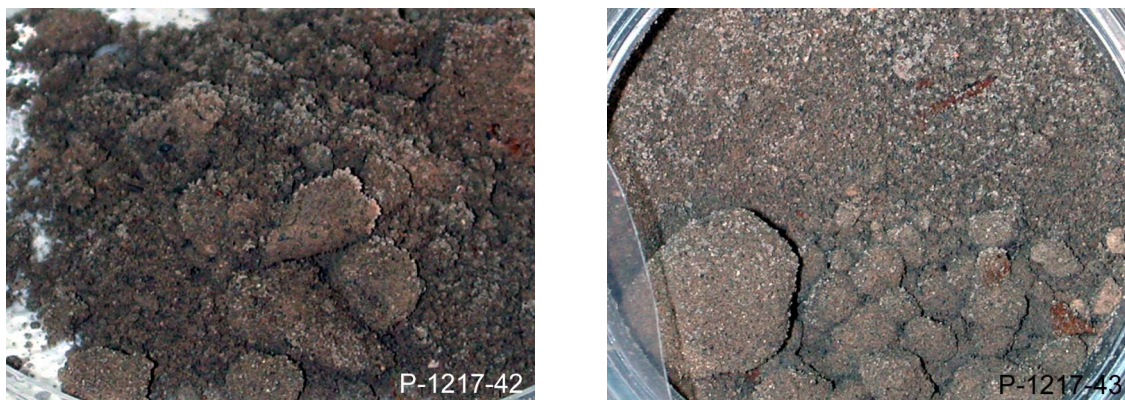
Figure C-20. A photographic image of sample P9GT12016G in a dish (left) in a jar (right).

Sample P9GT12016G was collected from scoop #1281 on February 14, 2004 at 22:42 hr at a reach of 9.42 ft, an angle of 11 degrees, and a depth of 14.79 ft. The field characterization identified the sample as interstitial soil. This scoop of material was acquired after four clean scoops of soil were removed from just to the right of the probe cluster. The sample material consisted of fine to medium granules of soil. The material was described as very moist granular soil located just to the left of the drum containing wood pieces and just to the right of the P9-20 probe cluster. The drum containing wood blocks located at an angle of 10 degrees and a depth of 13 ft, when removed, uncovered a void that contained standing water. Soil was used to absorb the water. Scoop #1281 was acquired from 11 degrees and 1.79 feet below that void. It was suspected that some of the free-standing water was absorbed by the nearby soil. No sludge was present in the sample. The interstitial soil characteristics were described as fine to medium grade. According to the hue guide (Geological Society of America 1991), the sample is recorded as 5YR 6/4-10YR 5/4 (light brown to light yellow brown). No free liquid was present although the sample was moist to very moist. It was unknown whether the moisture was due to standing water earlier absorbed, or as the original state of the material in that location of the pit. No organic sheen was observable. In the laboratory, after visual inspection and photographs, subsamples were obtained for analysis.

Exposed dumped drums and drum liners were present in near proximity. A rusted drum was present, additionally a stained bag was present. The integrity of nearby drums was described as poor as a result of the drum being thoroughly corroded and rusted and exposed to significant moisture. The drum liners observed were listed as being in conditions ranging from fair to poor. Moisture was present in the sampling region. The soil did not appear to be stained, only moist. Cardboard pieces and rusted metal pieces were listed as nearby debris. Clear plastic bags with opaque, stained, yellow tape were also present.

The field characterization identified the sample as interstitial soil. No visual signs of foreign material were present, except minor bits of drum rust were present. Rust was not significant in the sample. A small piece of possible off-white calcite was present.

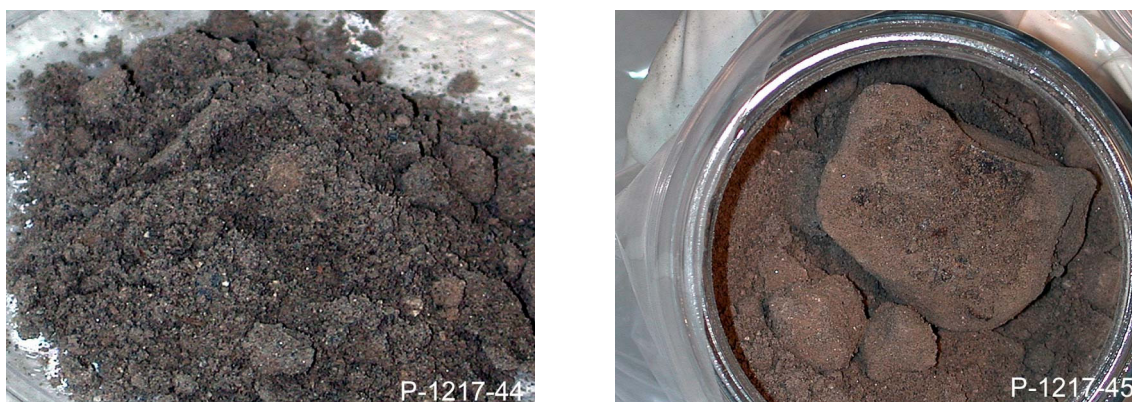
Figure C-21. A photographic image of sample P9GT13016G in a dish (left) in a jar (right).

Sample P9GT13016G was collected from scoop #2244 on February 17, 2004 at 10:28 hr at a reach of 9.89 ft, an angle of 11 degrees, and a depth of 14.76 ft. The scoop was collected as loose soil immediately beneath probe P9-20-06. The sample was collected from the front of the transfer cart. The field characterization identified the sample as interstitial soil. The leading edge was clumpy, similar to overburden. The sample color characteristics were described as 10YR 5/4 (Geological Society of America 1991) (yellowish brown). The main body of the sample was fine and dry. No pieces of bag were present. The sample did not have any characteristics of sludge. No free liquid or absorbed water were present. In the laboratory, after visual inspection and photographs, subsamples were obtained for analysis.

The dig was immediately adjacent to P9-20 probe and beneath the skewered drum. Mixing of soil appeared to have occurred. No container markings were present. The integrity of the drum was defined as heavily corroded. Intact bags were located within the skewered drums. The immediate dig area was dry and no soil stains were apparent.

The field characterization identified the sample as interstitial soil. Visually the sample appeared to be clean soil without any foreign material. Some small, hard clay chunks were mixed with some of the loose soil. Clay chunks were easily broken apart revealing soil centers. One or two small pieces of calcite were present.

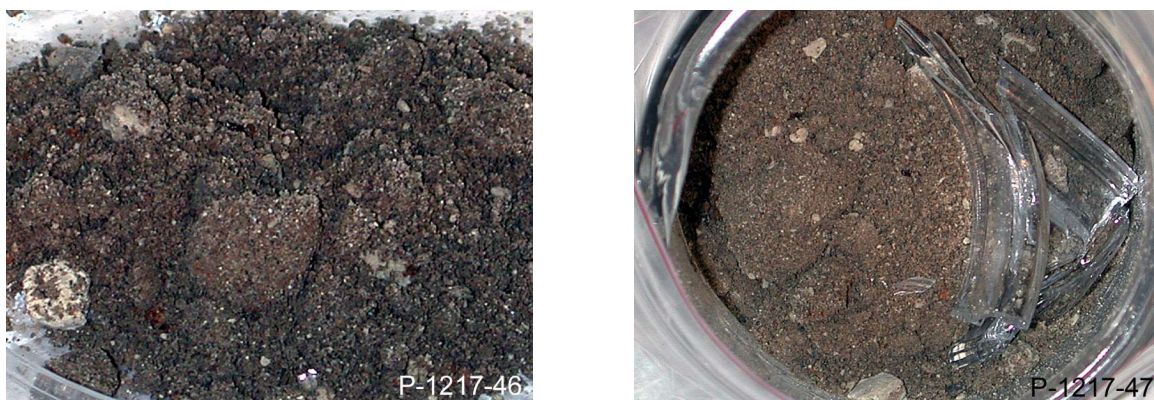
Figure C-22. A photographic image of sample P9GT14016G in a dish (left) in a jar (right).

Sample P9GT14016G was collected from scoop #2239 on February 17, 2004 at 02:05 hr at a reach of 7.99 ft, an angle of 9 degrees, and a depth of 14.69 ft. The scoop was low in the pit, where little soil mixing had occurred. The field characterization described the waste material in the transfer cart as interstitial soil with identifiable white chunks of calcite rock. The scoop was collected from a cavity around a corroded drum. The moisture that appeared to be present in the soil sample came from the cavity around the drum. The pit was very moist in that area. The transfer cart contained small particles of Series 743 organic sludge. The sludge was easily identified and segregated from the soil. Soil in the transfer cart was easily segregated from foreign materials. Neither free liquid nor absorbed liquid were present in the sample. In the laboratory, after visual inspection and photographs, subsamples were obtained for analysis.

The field characterization identified the sample as interstitial soil. Visually, the sample was classified as a soil sample. A small amount of apparent white calcite chunks were present. White chunks were solid and hard. The surface features resembled calcium carbonate. A few spots of rust were present. As shown in the digital image, the sample jar was received with a broken rim at the time of photography.

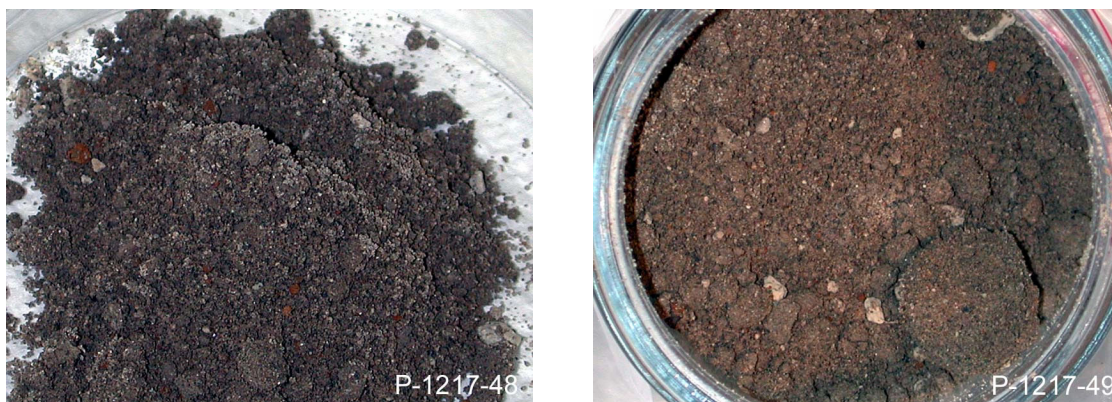
Figure C-23. A photographic image of sample P9GT15016G in a dish (left) in a jar (right).

Sample P9GT15016G was collected from scoop #2239 on February 17, 2004 at 02:05 hr at a reach of 7.99 ft, an angle of 9 degrees, and a depth of 14.69 ft. The scoop was low in the pit, where little mixing had occurred. The field characterization described the waste material in the cart as interstitial soil with white chunks of apparent calcite. The sample was collected from a cavity around a corroded drum. The moisture that appeared to be present came from the cavity around the drum. The material in the transfer cart contained a small amount of apparent Series 743 organic sludge that was easily identified and segregated from the soil. Neither free liquid nor absorbed liquid were present in the sample. In the laboratory, after visual inspection and photographs, subsamples were obtained for analysis.

The field characterization described the sample as interstitial soil. Visually the sample consisted of soil with small amounts of foreign material (apparent calcite). A couple of rust spots were present.

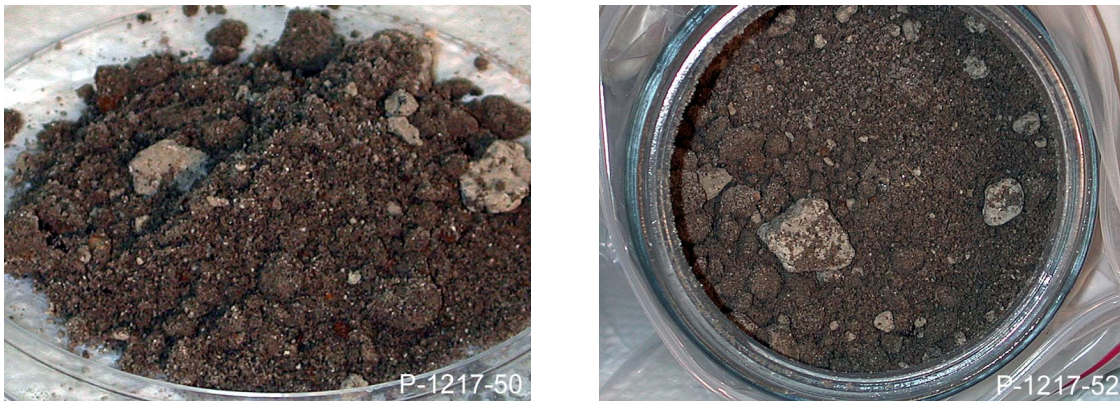
Figure C-24. A photographic image of sample P9GT16016G in a dish (left) in a jar (right).

Sample P9GT16016G was collected from scoop #2239 on February 17, 2004 at 02:05 hr at a reach of 7.99 ft, an angle of 9 degrees, and a depth of 14.69 ft. The scoop was low in the pit, where little mixing had occurred. The field characterization described the waste material in the cart as interstitial soil with apparent white chunks of calcite rock. The scoop was collected from a cavity around a corroded drum. The moisture that appeared to be present came from the cavity around the drum. The material in the transfer cart contained a small amount of apparent Series 743 organic sludge that was easily identified and segregated from the soil. Neither free liquid nor absorbed liquid was present in the sample. In the laboratory, after visual inspection and photographs, subsamples were obtained for analysis.

The field characterization described the sample as interstitial soil. Visually the sample appeared as soil with some apparent white chunks of calcite. Minor amounts of foreign debris were present, such as drum rust.

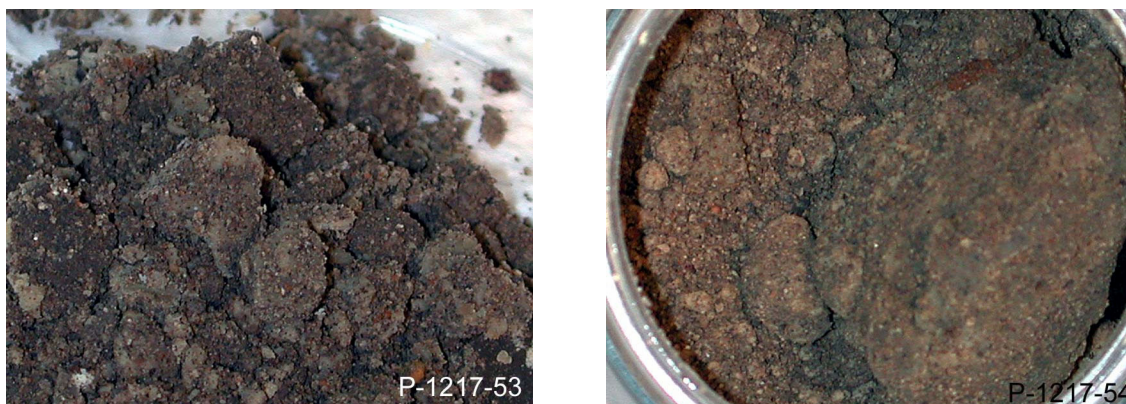
Figure C-25. A photographic image of sample P9GT17016G in a dish (left) in a jar (right).

Sample P9GT17016G was collected from scoop #2239 on February 17, 2004 at 02:05 hr at a reach of 7.99 ft, an angle of 9 degrees, and a depth of 14.69 ft. The contents in the transfer cart contained mostly soil with a few discrete off-white chunks of unidentified material and some identifiable pieces of probable Series 743 organic sludge. Soil, unidentified materials, and probable sludge were easily segregated and clean soil samples were acquired. The scoop came from low in the pit in an area where little soil mixing had occurred. An intact waste drum was “plucked” from the angle of repose exposing behind it undisturbed soil. The heavy equipment operator was instructed to scoop into the cavity and remove soil. Soil that was collected was moist, but there were no free liquids visible. The intact waste drum contained no distinguishable markings, but was later noted to contain probable Series 743 organic sludge. The comment was documented that the scoop came from low in the pit where little mixing had occurred. Hence, the field representative stated that good interstitial soil samples were collected from a cavity around a corroded drum.

The sample was described as a soil that appears to have been saturated with organics or oil. The sample appeared moist and dark but not from water. The sample was described as being clumped. The sample contained in the jar was observed as being greater than 99% soil. Some pieces of rust and corroded drum were present, but could be segregated. Subsamples of soil free of foreign debris were obtained.

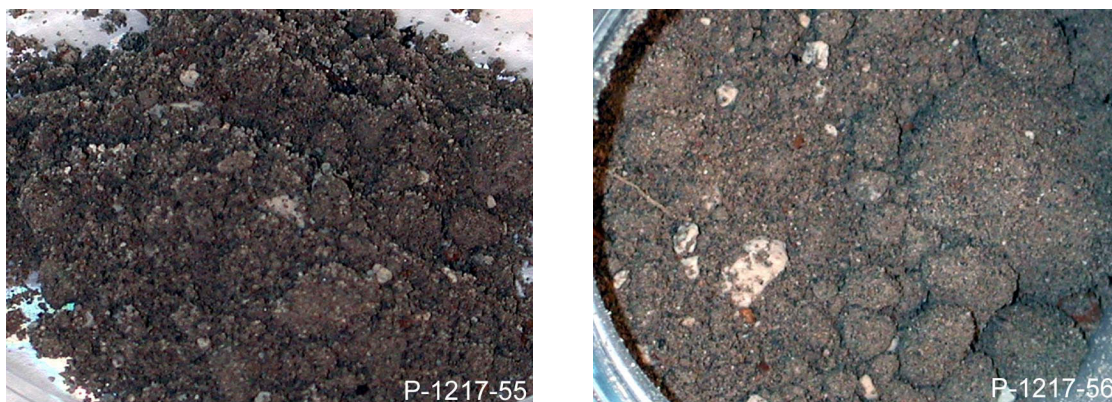
Figure C-26. A photographic image of sample P9GT18016G in a dish (left) in a jar (right).

Sample P9GT18016G was collected from scoop #2239 on February 17, 2004 at 02:05 hr at a reach of 7.99 ft, an angle of 9 degrees, and a depth of 14.69 ft. The scoop was low in the pit, where little mixing had occurred. The field characterization described the waste material in the cart as interstitial soil with apparent white chunks of calcite. The scoop was collected from a cavity around a corroded drum. The moisture that appeared to be present came from the cavity around the drum. Soil and other materials in the transfer cart were easily identifiable and easily segregated. Neither free liquid nor absorbed liquid were present in the sample. In the laboratory, after visual inspection and photographs, subsamples were obtained for analysis.

The field characterization described the sample as interstitial soil. The sample appeared to have chunks of clay and soil with hard off-white material resembling calcite present when examined for photography. The off-white chunks were small (1–2 mm in diameter). The soil was otherwise clean with a few spots of rust and a small piece of what appeared to be plant root material. No other major foreign debris was present.

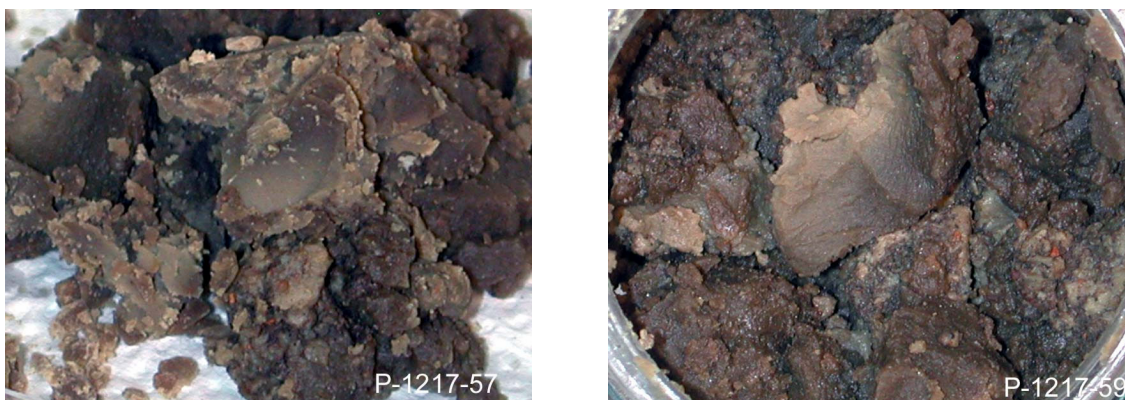
Figure C-27. A photographic image of sample P9GT19016G in a dish (left) in a jar (right).

Sample P9GT19016G was collected from scoop #2239 on February 17, 2004 at 02:05 hr at a reach of 7.99 ft, an angle of 9 degrees, and a depth of 14.69 ft. The scoop was low in the pit, where little previous soil mixing had occurred. The field characterization described the waste material in the cart as mostly interstitial soil with apparent white chunks of calcite. The scoop was collected from a cavity around a corroded drum. The moisture that appeared to be present came from the cavity around the drum. The materials in the transfer cart were easily identifiable and easily segregated. Neither free liquid nor absorbed liquid were present in the sample. In the laboratory, after visual inspection and photographs, subsamples were obtained for analysis.

The field characterization described the sample as interstitial soil. When the sample was examined for photography, it was noted that the sample appeared to be saturated with organic material that had occurred over an extended period. The sample had a greasy sheen. Only clumped soil was present with no visible foreign materials.

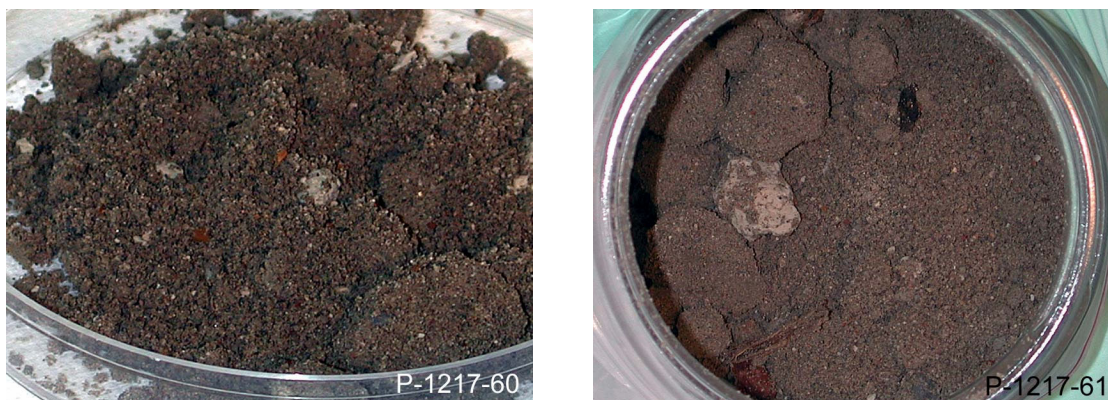
Figure C-28. A photographic image of sample P9GT20016G in a dish (left) in a jar (right).

Sample P9GT20016G was collected from scoop #2239 on February 17, 2004 at 02:05 hr at a reach of 7.99 ft, an angle of 9 degrees, and a depth of 14.69 ft. The scoop was low in the pit, where little previous mixing had occurred. The field characterization described the material in the cart as interstitial soil with apparent off-white chunks of calcite. The scoop was collected from a cavity around a corroded drum. The moisture that appeared to be present came from the cavity around the drum. The materials in the transfer cart were easily identifiable and easily segregated. The sample had no free liquid or absorbed liquid present. In the laboratory, after visual inspection and photographs, subsamples were obtained for analysis.

The field characterization described the sample as interstitial soil. Visual analysis at the time of sample photography showed the sample as having some off-white chunks of apparent calcite and a small bit of drum rust mixed with the soil. Visual examination and review of sample photographs displayed no evidence of sludge or debris foreign inclusions.

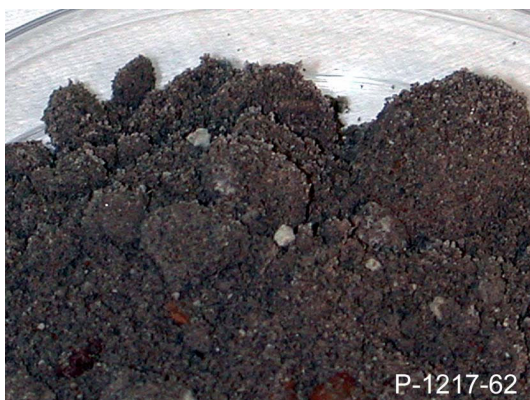
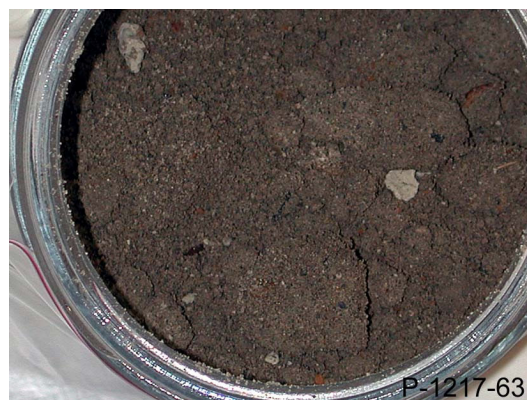
Figure C-29. A photographic image of sample P9GT21016G in a dish (left) in a jar (right).

Sample P9GT21016G was collected from scoop #2239 on February 17, 2004 at 02:05 hr at a reach of 7.99 ft, an angle of 9 degrees, and a depth of 14.69 ft. The scoop was low in the pit, where little previous mixing had occurred. The field characterization described the waste material in the cart as interstitial soil with apparent off-white chunks of calcite. The scoop was collected from a cavity around a corroded drum. The moisture that appeared to be present came from the cavity around the drum. The materials present in the transfer cart were easily identifiable and easily segregated. Neither free liquid nor absorbed liquid were present in the sample. In the laboratory, after visual inspection and photographs, subsamples were obtained for analysis.

The field characterization described the sample as interstitial soil. At the time of photography, the sample had a few white pieces of apparent calcite.

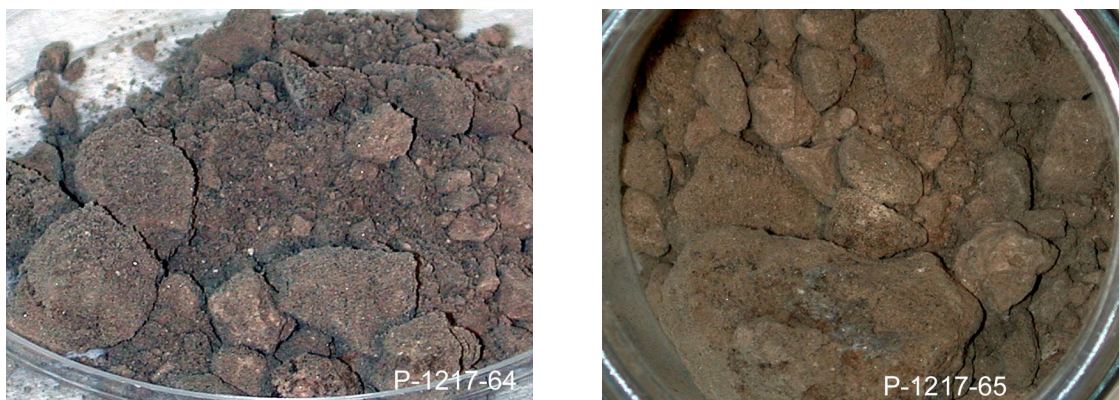
Figure C-30. A photographic image of sample P9GT22016G in a dish (left) in a jar (right).

Sample P9GT22016G was collected from scoop #2244 on February 17, 2004 at 10:28 hr at a reach of 9.89 ft, an angle of 11 degrees, and a depth of 14.76 ft. The scoop was collected as loose soil immediately beneath probe P9-20-06. The sample was collected from the front of the cart. The field characterization identified the sample as interstitial soil. The leading edge was clumpy, resembling overburden. The sample color characteristics were described as 10YR 5/4 (Geological Society of America 1991) (moderate yellowish brown). The main body of the sample was fine and dry. No pieces of bag were present. The sample did not have any characteristics of sludge. Neither free liquid nor absorbed water were present. In the laboratory, after visual inspection and photographs, subsamples were obtained for analysis.

The dig was immediately adjacent to P9-20 probe and beneath the skewered drum. Mixing of soil appeared to have occurred. No container markings were present. The integrity of the drum was defined as heavily corroded. Intact bags were located within the skewered drums. The immediate dig area was dry and no soil stains were apparent.

The field characterization described the sample as interstitial soil. The sample showed a few large clay chunks, a few apparent calcite chunks, but no apparent foreign material.

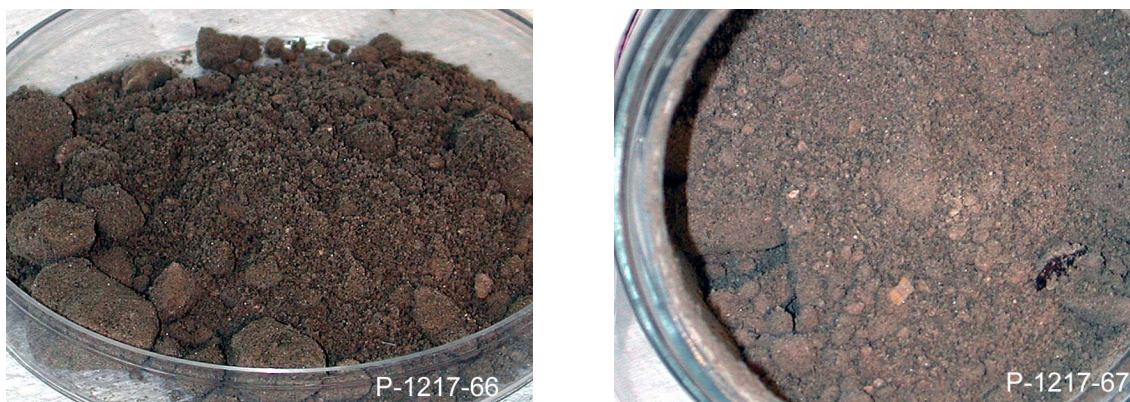
Figure C-31. A photographic image of sample P9GT23016G in a dish (left) in a jar (right).

Sample P9GT23016G was collected from scoop #2244 on February 17, 2004 at 10:28 hr at a reach of 9.89 ft, an angle of 11 degrees, and a depth of 14.76 ft. The sample was collected as loose soil immediately beneath probe P9-20-06. The scoop was collected as fine soil near the top of the pile from the transfer cart. The field characterization identified the sample as interstitial soil; the leading edge was clumpy, resembling overburden. The sample color characteristics were described as 10YR 5/4 (Geological Society of America 1991) (moderate yellowish brown). The main body of the sample was fine and dry. No pieces of bag were present. The sample did not have any characteristics of sludge. Neither free liquid nor absorbed water were present in the sample. In the laboratory, after visual inspection and photographs, subsamples were obtained for analysis.

The dig was immediately adjacent to P9-20 probe and beneath the skewered drum. Mixing of soil appeared to have occurred. No container markings were present. The integrity of the drum was defined as heavily corroded. Intact bags were located within the skewered drums. The immediate dig area was dry and no soil stains were apparent.

The field characterization described the sample as interstitial soil. Detailed visual analysis at the time of photography confirmed the field characterization of a soil sample. The sample showed a few large clay chunks. Some minor foreign material and a small piece of drum rust were present.

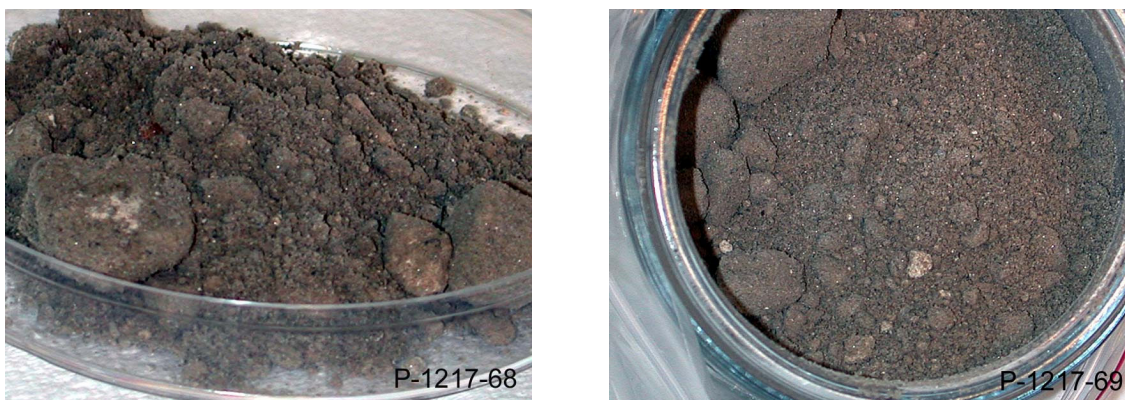
Figure C-32. A photographic image of sample P9GT24016G in a dish (left) in a jar (right).

Sample P9GT24016G was collected from scoop #2244 on February 17, 2004 at 10:28 hr at a reach of 9.89 ft, an angle of 11 degrees, and a depth of 14.76 ft. The sample was collected as loose soil immediately beneath probe P9-20-06. The scoop was collected as fine soil near the top of the pile from the transfer cart. The field characterization for the sample was interstitial soil resembling overburden. The sample color characteristics were described as 10YR 5/4 (Geological Society of America 1991) (moderate yellowish brown). The leading edge of the sample was clumpy. The main body of the sample was fine and dry. No pieces of bag were present. The sample did not have any characteristics of sludge. Neither free liquid nor absorbed water were present in the sample. In the laboratory, after visual inspection and photographs, subsamples were obtained for analysis.

The dig was immediately adjacent to P9-20 probe and beneath the skewered drum. Mixing of soil appeared to have occurred. No container markings were present. The integrity of the drum was defined as heavily corroded. Intact bags were located within the skewered drums. The immediate dig area was dry and no soil stains were apparent.

The field characterization described the sample as interstitial soil. Detailed visual analysis at photography confirmed the field characterization of a soil sample. The sample showed a few large clay chunks but no apparent foreign material. Some calcite pieces were present.

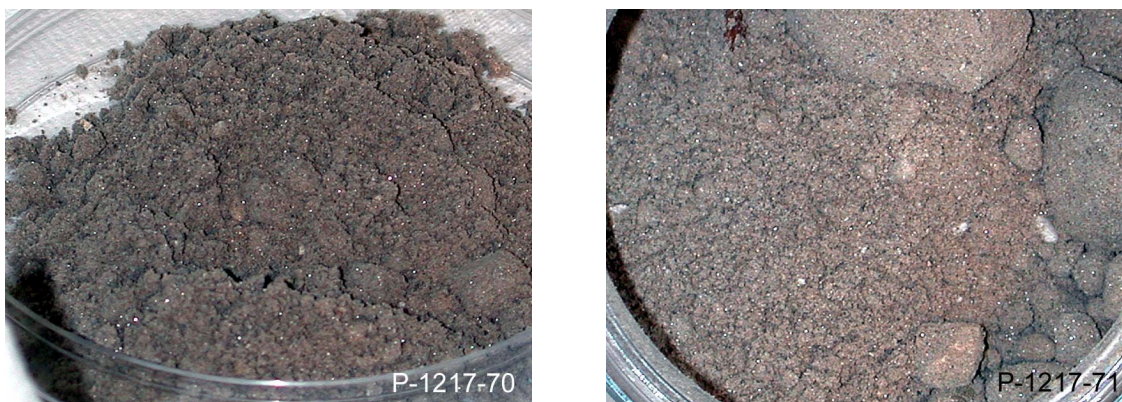
Figure C-33. A photographic image of sample P9GT25016G in a dish (left) in a jar (right).

Sample P9GT25016G was collected from scoop #2244 on February 17, 2004 at 10:28 hr at a reach of 9.89 ft, an angle of 11 degrees, and a depth of 14.76 ft. The sample was collected as loose soil immediately beneath probe P9-20-06. The sample was collected as fine soil from near the bottom of pile in the transfer cart. The field characterization for the sample was interstitial soil resembling overburden. The sample color characteristics were described as 10YR 5/4 (Geological Society of America 1991) (moderate yellowish brown). The leading edge of the sample was clumpy. The main body of the sample was fine and dry. No pieces of bag were present. The sample did not have any characteristics of sludge. No free liquid or absorbed water were present. In the laboratory, after visual inspection and photographs, subsamples were obtained for analysis.

The dig was immediately adjacent to P9-20 probe and beneath the skewered drum. Mixing of soil appeared to have occurred. No container markings were present. The integrity of the drum was defined as heavily corroded. Intact bags were located within the skewered drums. The immediate dig area was dry and no soil stains were apparent.

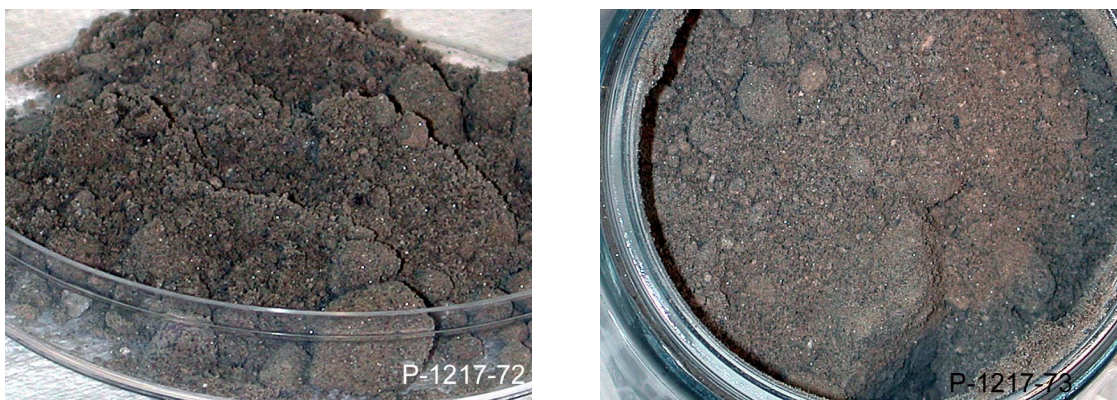
Figure C-34. A photographic image of sample P9GT26016G in a dish (left) in a jar (right).

Sample P9GT26016G was collected from scoop #2244 on February 17, 2004 at 10:28 hr at a reach of 9.89 ft, an angle of 11 degrees, and a depth of 14.76 ft. The scoop was collected as loose soil immediately beneath probe P9-20-06. The sample was collected as fine soil from near the bottom of the pile in the transfer cart. The field characterization for the sample was interstitial soil resembling overburden. The sample color characteristics were described as 10YR 5/4 (Geological Society of America 1991) (moderate yellowish brown). The leading edge of the sample was clumpy. The main body of the sample was fine and dry. No pieces of bag were present. The sample did not have any characteristics of sludge. No free liquid or absorbed water were present. In the laboratory, after visual inspection and photographs, subsamples were obtained for analysis.

The dig was immediately adjacent to P9-20-06 probe and beneath the skewered drum. Mixing of soil appeared to have occurred. No container markings were present. The integrity of the drum was defined as heavily corroded. Intact bags were located within the skewered drums. The immediate dig area was dry and no soil stains were apparent.
